How to avoid image distortion due to the ponding water on the ClearSight dome cover

Updated: Mar., 2021

Issued: July, 2020

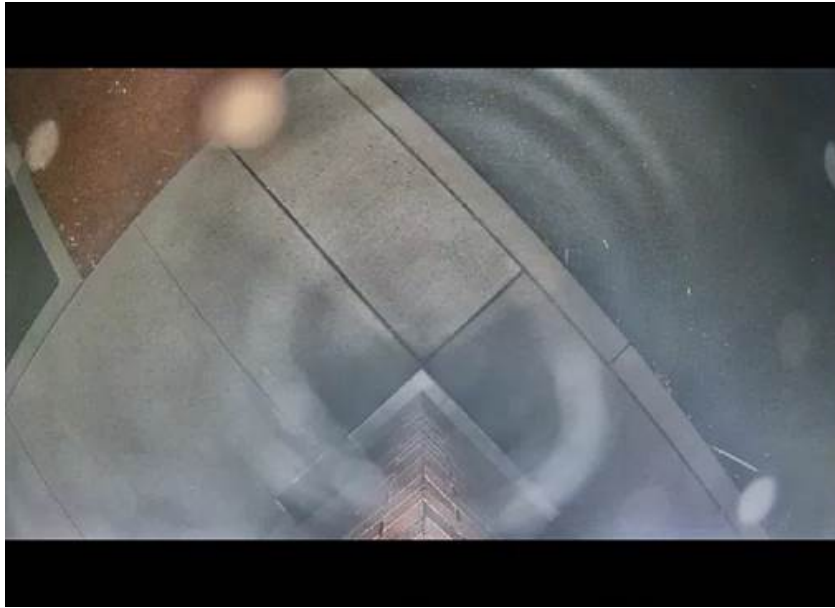
The multi-sensor cameras have poor visibility at the bottom in the raining.

Water is ponding at the bottom of the dome. This is caused by ClearSight coating.

Change the tilt angle to avoid affect by the ponding water

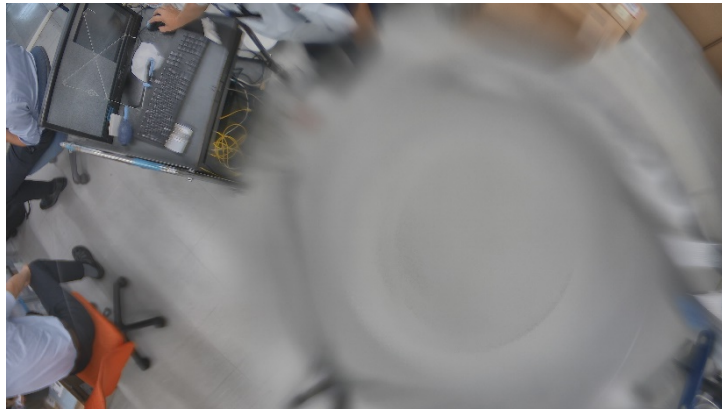
Difference in vision with ponding water

Difference between Tilt angle 0 deg and 10 deg

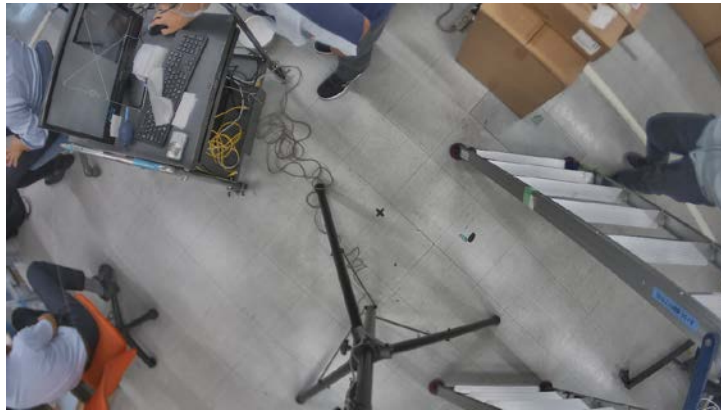
Difference in vision without ponding water

Difference between Tilt angle 0 deg and 10 deg
