## Vertical Image Distortion on network cameras using the MOS Sensor

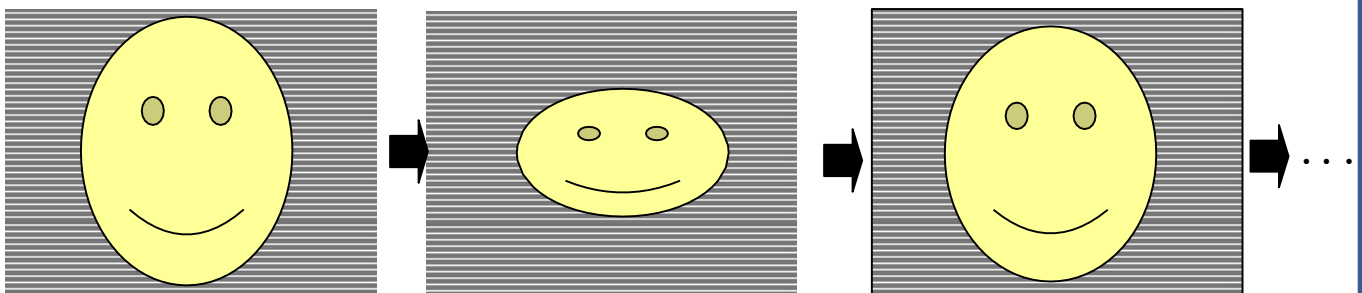
The subject is distorted by applying vibration to the camera under the influence of a method (rolling shutter) that reads out signals for each scanning line (line) unique to the MOS sensor. This is a phenomenon that commonly occurs with cameras equipped with MOS sensors and is NOT a malfunction.

The following distortion images are extreme images for understanding the phenomenon and are different from the actual images.

It looks stretched.

It looks shrunk.

**The cause of the vibration can be eliminated by removing it or relocating it to a place without vibration.**

By increasing the frame rate or using the shutter, the distortion of the image changes into slight shaking but it is NOT a solution of the problem.
