How to avoid image distortion due to the ponding water on the ClearSight dome cover

Updated: Mar., 2021

Issued: July, 2020

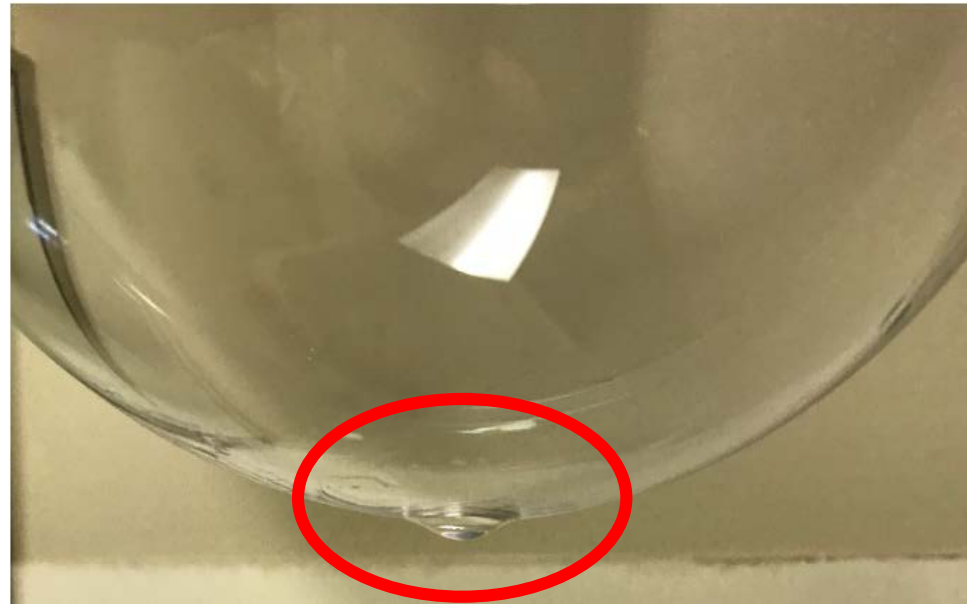
The multi-sensor cameras have poor visibility at the bottom in the raining.

Water is ponding at the bottom of the dome. This is caused by ClearSight coating.

Change the tilt angle to avoid affect by the ponding water

The influence of waterdrop can be avoided by tilting lens unit for 2 notches (Tilt angle 10 deg)
